**CLS**  
 CUMBERLAND LAND SURVEYORS  
 300 CAMDEN AVENUE  
 WOODBINE, GA 31569  
 (912) 576-8854

DWG. BY: SH | P.M.: ET  
 DWG. DATE: 3/26/2008 | SURVEYED: SEE REF.  
 JOB: 08032 | 1" = 60'  
 SHEET 1 of 6

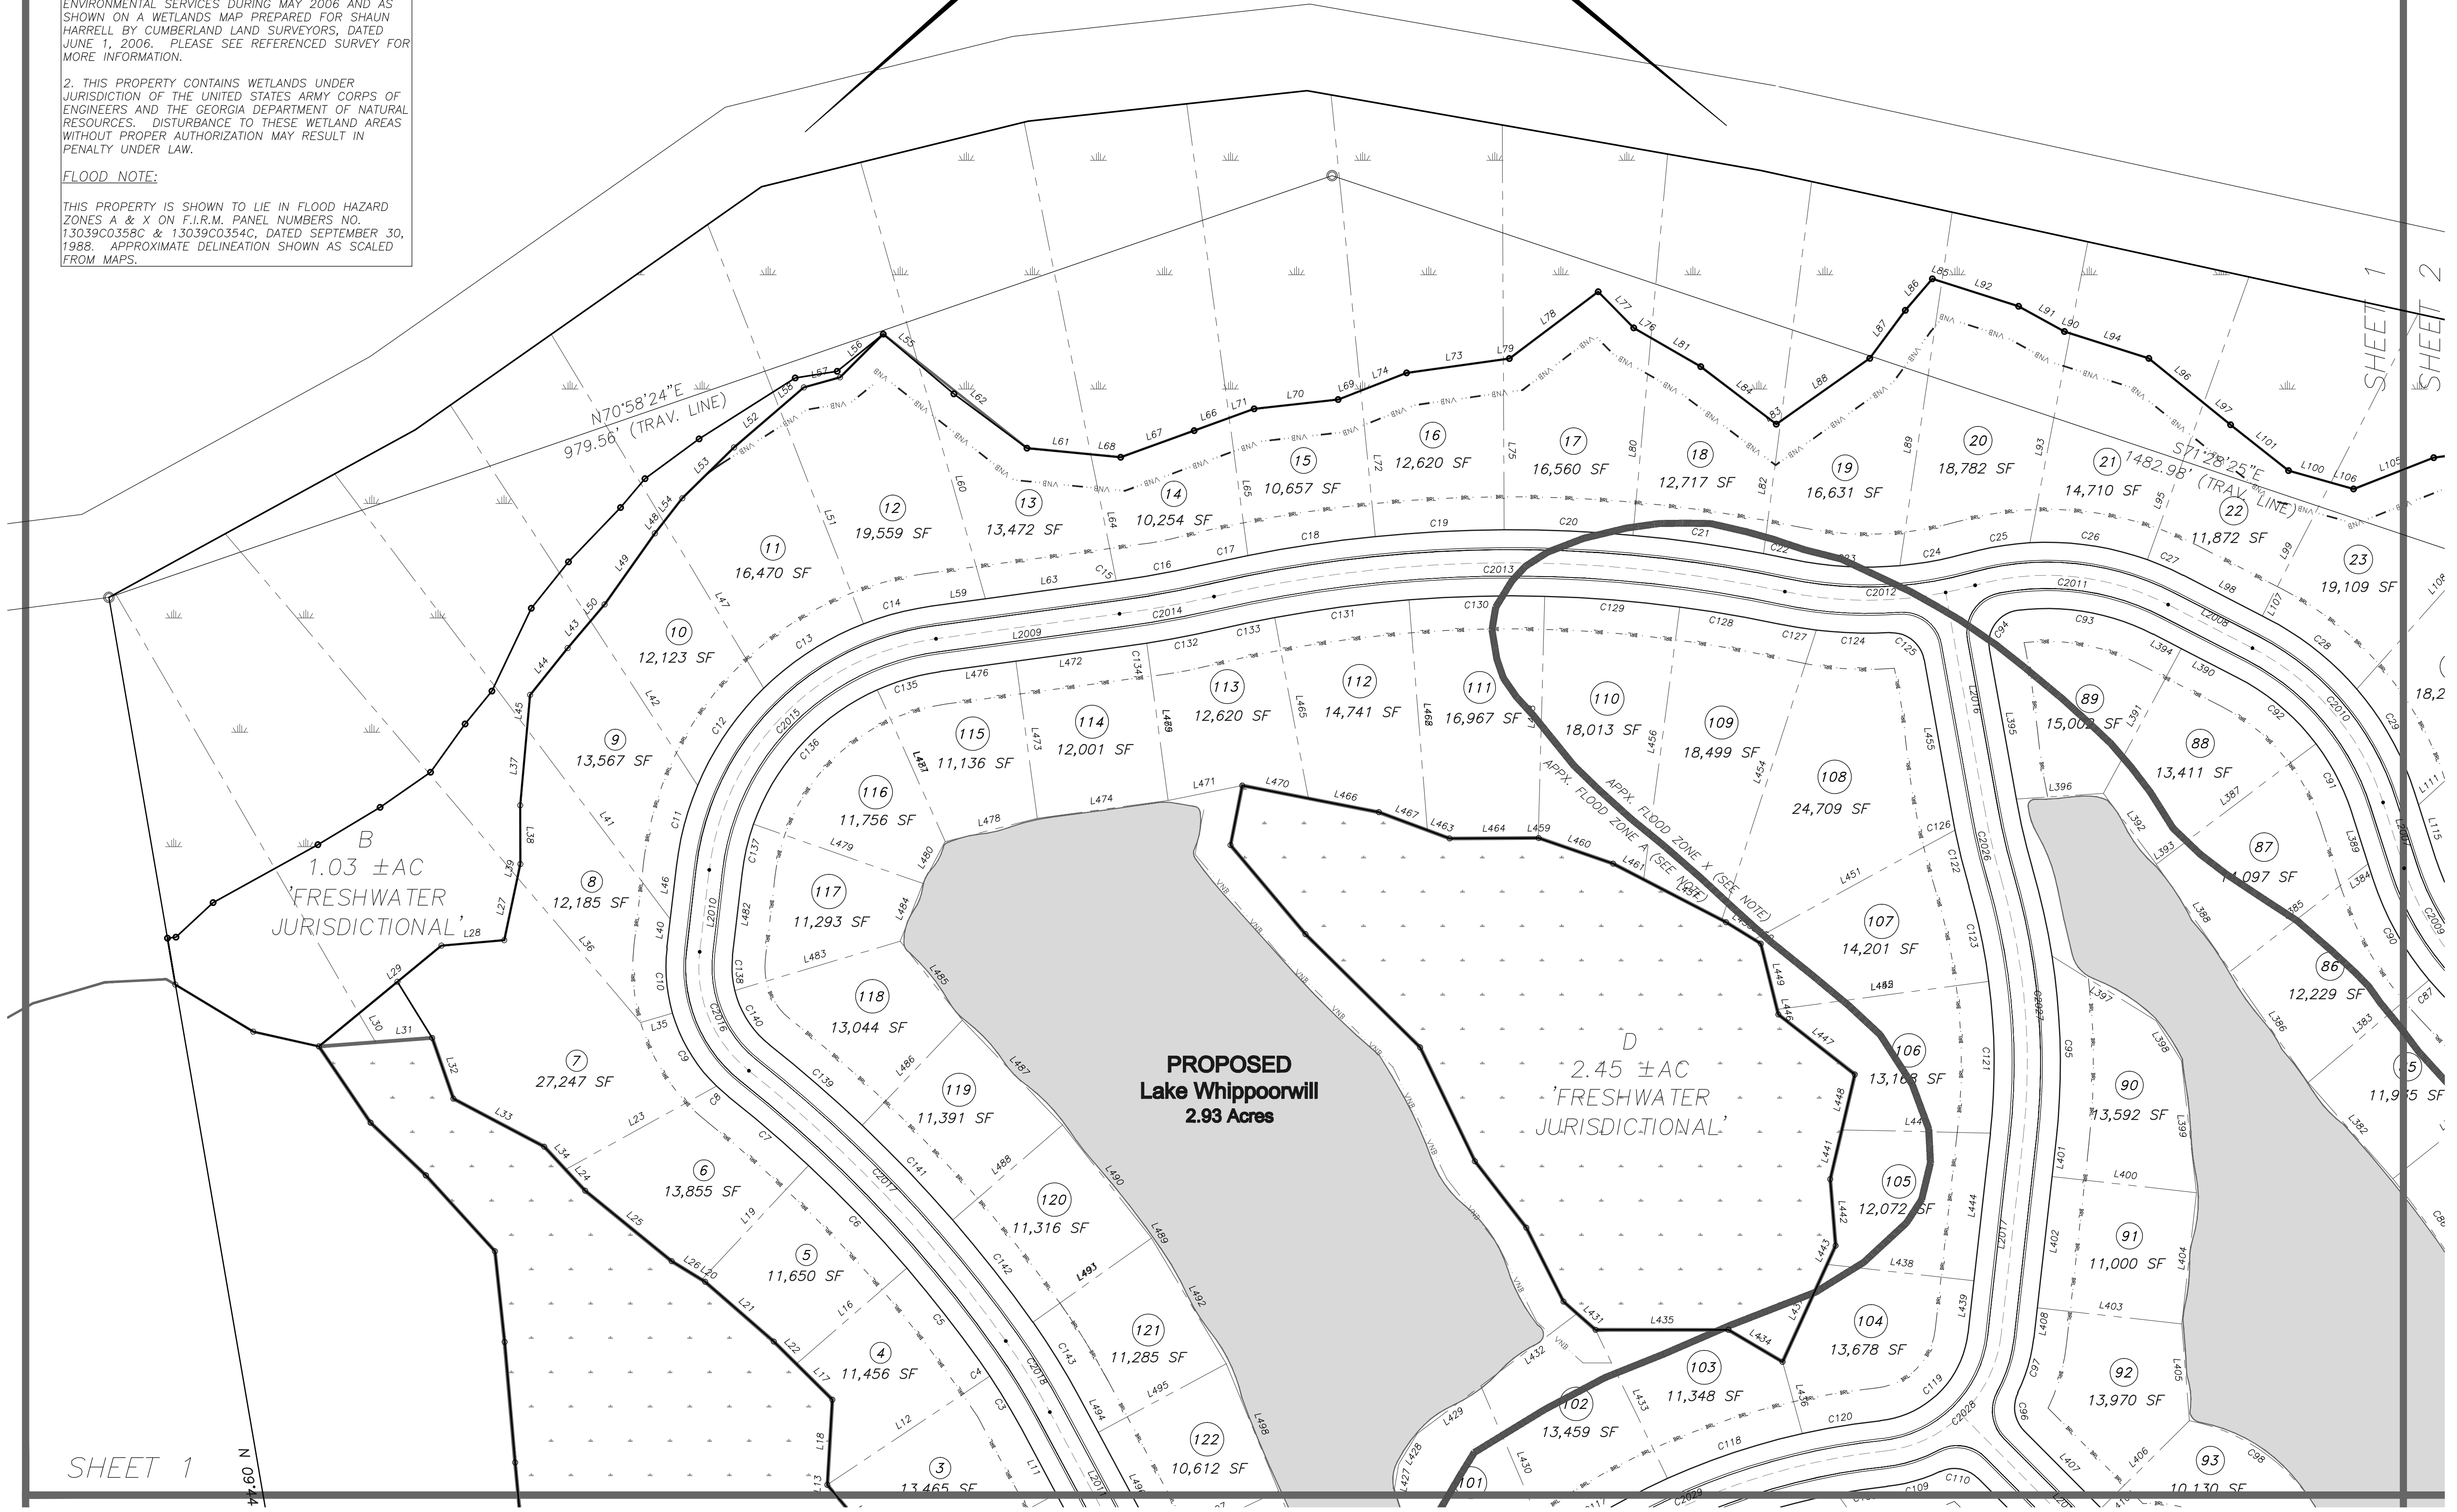
SHEET 1

**WETLANDS NOTES:**  
 1. WETLANDS SHOWN AS DELINEATED BY COASTAL ENVIRONMENTAL SERVICES DURING MAY 2006 AND AS SHOWN ON A WETLANDS MAP PREPARED FOR SHAUN HARRELL BY CUMBERLAND LAND SURVEYORS, DATED JUNE 1, 2006. PLEASE SEE REFERENCED SURVEY FOR MORE INFORMATION.  
 2. THIS PROPERTY CONTAINS WETLANDS UNDER JURISDICTION OF THE UNITED STATES ARMY CORPS OF ENGINEERS AND THE GEORGIA DEPARTMENT OF NATURAL RESOURCES. DISTURBANCE TO THESE WETLAND AREAS WITHOUT PROPER AUTHORIZATION MAY RESULT IN PENALTY UNDER LAW.  
**FLOOD NOTE:**  
 THIS PROPERTY IS SHOWN TO LIE IN FLOOD HAZARD ZONES A & X ON F.I.R.M. PANEL NUMBERS NO. 13039C0359C & 13039C0354C, DATED SEPTEMBER 30, 1986. APPROXIMATE DELINEATION SHOWN AS SCALED FROM MAPS.

CROOKED RIVER IS PROPERTY LINE
